737 GRAPHITE COMPOSITE FLIGHT SPOILER FLIGHT SERVICE EVALUATION

THIRD ANNUAL REPORT
APRIL 1976 THROUGH APRIL 1977

Prepared under contract NAS1-11668 by
BOEING COMMERCIAL AIRPLANE COMPANY
P.O. Box 3707
Seattle, Washington 98124

August 1977

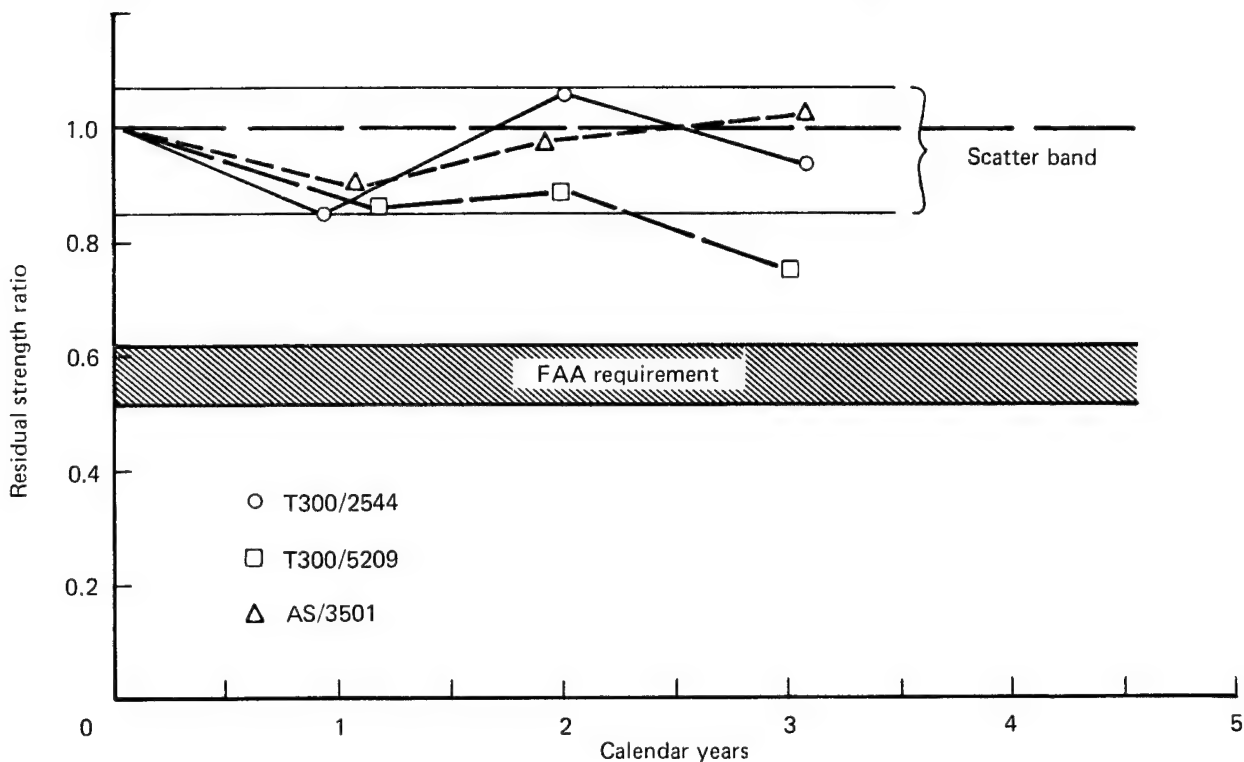
Figure 2. — Residual Strength After Exposure

A plot of the residual static strength data accumulated to date appears in figure 2, and is plotted as a function of time. This data not only continues to point out the scatter in the strength data being collected, but begins to show an identifiable trend relative to both the 250° F curing system and the 350° F curing systems. As shown in figure 2, both 350° F systems are maintaining a relative stability in residual strength as contrasted to the 250° F system.

The scatter band represented by these values is displayed graphically on figure 2. Consideration of this scatter contributes to the previous observation that the 350° F curing systems are maintaining relatively stable residual strength.

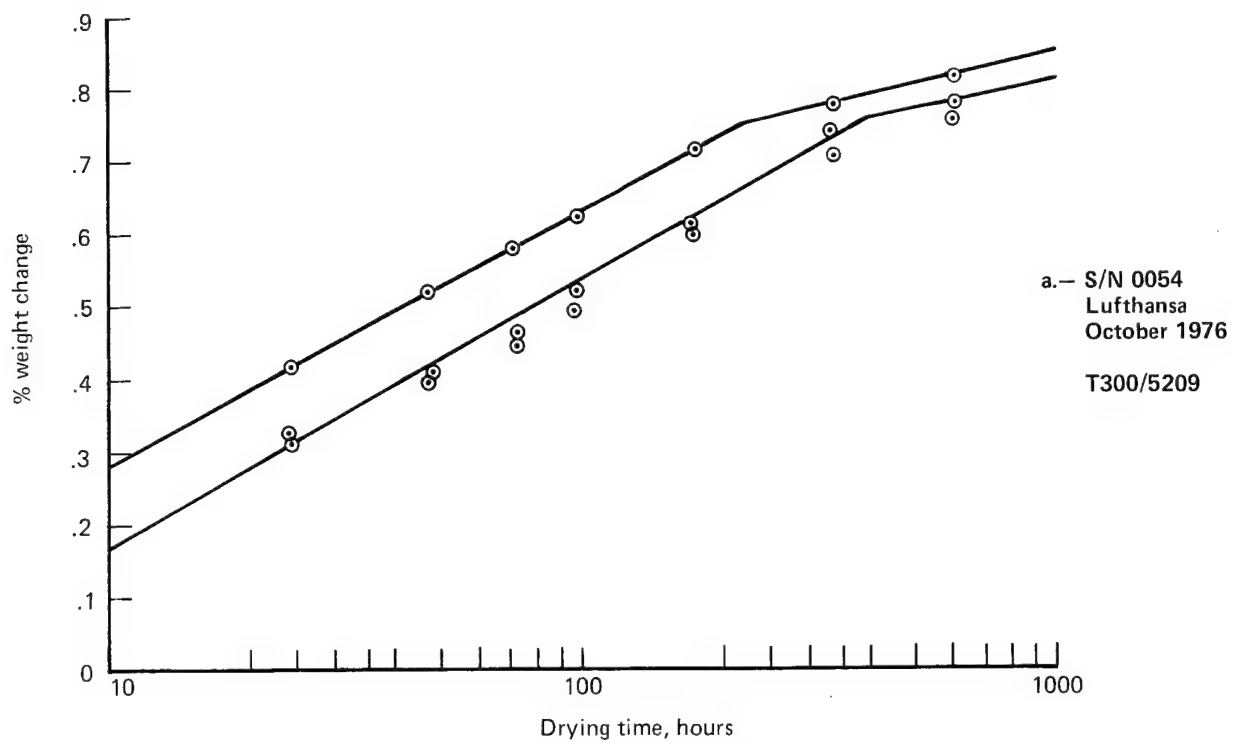
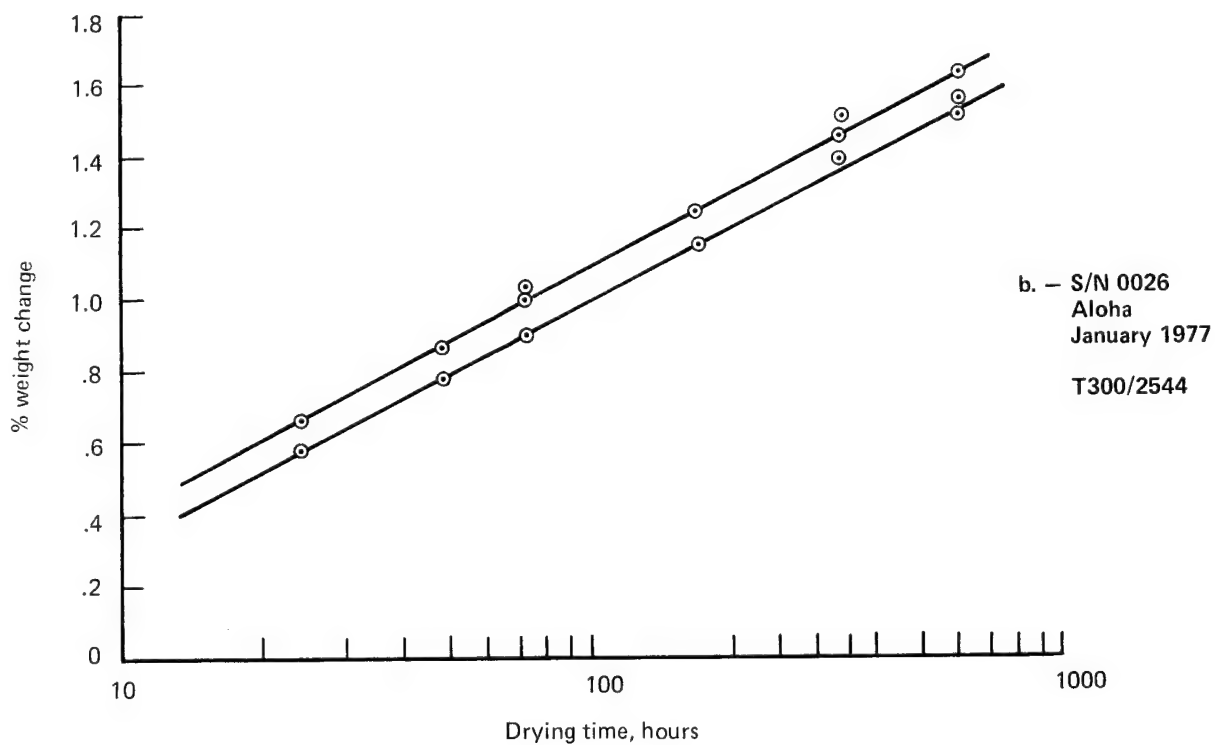
Figure 6. — Moisture Weight Change

The core samples (three per spoiler) are subjected to a 25-day drying environment at 160° F. The samples are weighed at discreet intervals in order to construct the weight-loss curve, an example of which is shown in figure 6. Actual weights of EA9628 adhesive and calculated weights of aluminum core are included in the final values. The final delta weights include moisture absorbed by the laminates and by the two layers of adhesive. Separation of the moisture content in each medium remains to be accomplished.

Two spoiler panels (S/N 0026 and S/N 0054) have been core-sampled prior to static test. The results of drying these samples are given in figure 6. Correlation of the effect of moisture absorption on the residual strength of the spoiler panels remains to be accomplished.

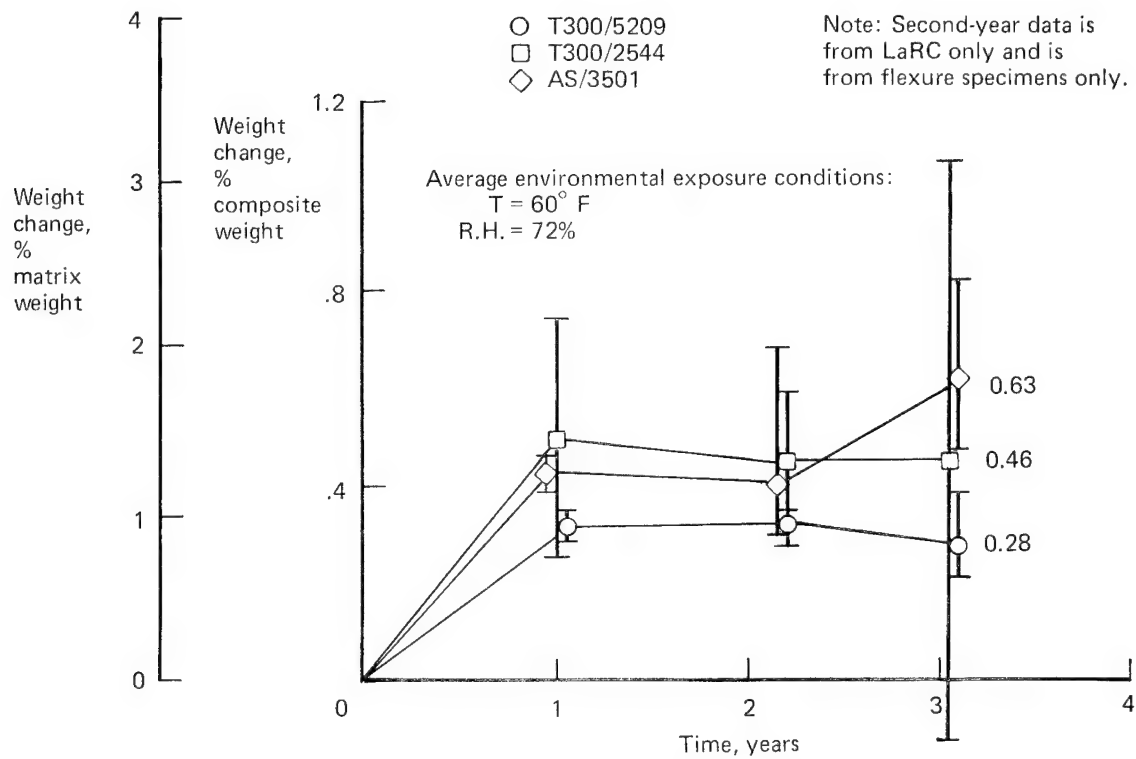
Figure 11. — Moisture Pickup in Exposed Epoxy-Matrix Laminates

Material property specimens were removed from the ground-based environmental exposure program following the third year of exposure. The specimens were returned from the various sites to NASA-Langley for laboratory evaluation. The reduced moisture absorption data has been plotted in figure 11, which also contains the first year data and the "NASA-only" second year moisture data. Current program plans call for a retrieval schedule at the completion of 1, 3, 5, 7 and 10 years of exposure.

The plotted data continued to exhibit a stabilizing trend, with an increasing scatter within the averages. The tabulated moisture data is presented in tables 9, 10, and 11. Plots of strength retention similar to those that appeared in references (1) and (2) are shown in figures 12, 13, and 14. The data for the strength retention plots is also included in tables 9, 10, and 11.
